# Manhole Inspection Summary

Manhole # S39Q\_\_017MH

Record Plat: **39Q** Node: **017** Status: **New Manhole (Not in GIS)** Insp Date: **9/16/08 12:00 AM**

**Location** Address: **1215 harbor island walk** Cross Street: **harborview dr**

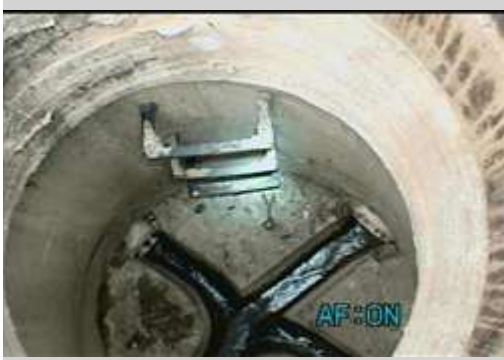
Defect 1

**Frame** Offset: **0** (in.) Condition: ☐ Sound ☐ Cracked ☒ **Leaks**

**Steps** Count: **3** Missing: **0** ☒ **Corroded**

corroded steps, frame infiltration

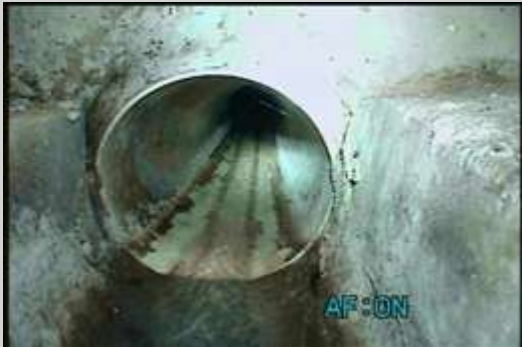
12 O'Clock Outflow

8 in. Circular Gravity Sewer  
Pipe Out @ 12 O'Clock

Pipe Material: PVC ☐ Pipe Lined

Invert Depth: 6.92 (ft.) Flow Characteristics: Fast

Deposits: ☒ None ☐ Mud ☐ Sludge ☐ Debris ☐ Grease

Infiltration: None Pipe Seal Cond: Unknown

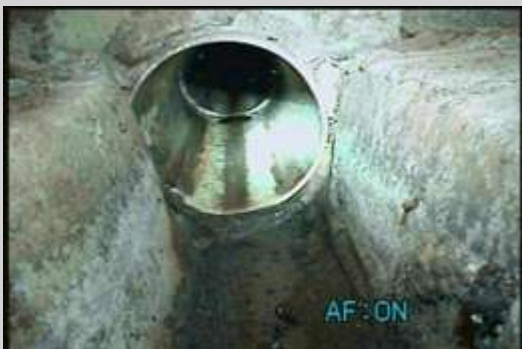
3 O'Clock Inflow

8 in. Circular Gravity Sewer  
Pipe In @ 3 O'Clock

Pipe Material: PVC ☐ Pipe Lined

Invert Depth: 6.61 (ft.) Flow Characteristics: Fast

Deposits: ☒ None ☐ Mud ☐ Sludge ☐ Debris ☐ Grease

Infiltration: None Pipe Seal Cond: Unknown

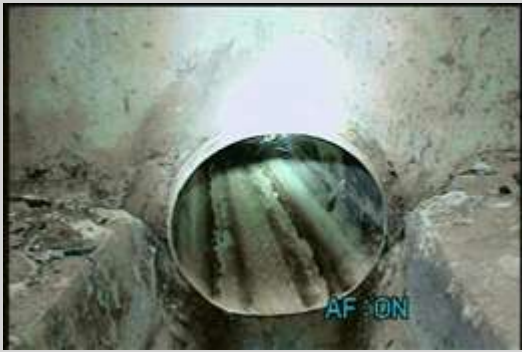
7 O'Clock Inflow

Pipe In @ 7 O'Clock

Pipe Material: **PVC** ☐ Pipe Lined

Invert Depth: **6.70** (ft.) Flow Characteristics: **Fast**

Deposits: ☒ None ☐ Mud ☐ Sludge ☐ Debris ☐ Grease

Infiltration: **None** Pipe Seal Cond: **Unknown**

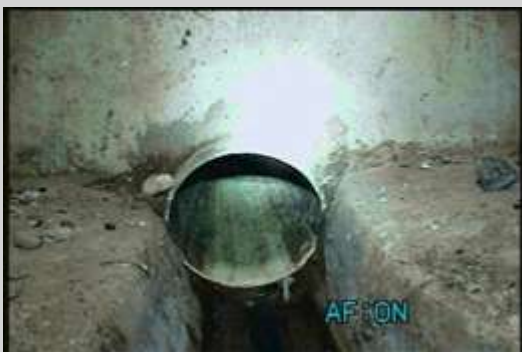
9 O'Clock Inflow

Pipe In @ 9 O'Clock

Pipe Material: **PVC** ☐ Pipe Lined

Invert Depth: **6.67** (ft.) Flow Characteristics: **Fast**

Deposits: ☒ None ☐ Mud ☐ Sludge ☐ Debris ☐ Grease

Infiltration: **None** Pipe Seal Cond: **Unknown**
